Building Sciences Consultants

Capital Needs Assessment

Community School of Davidson

Inspection Number: 20230103

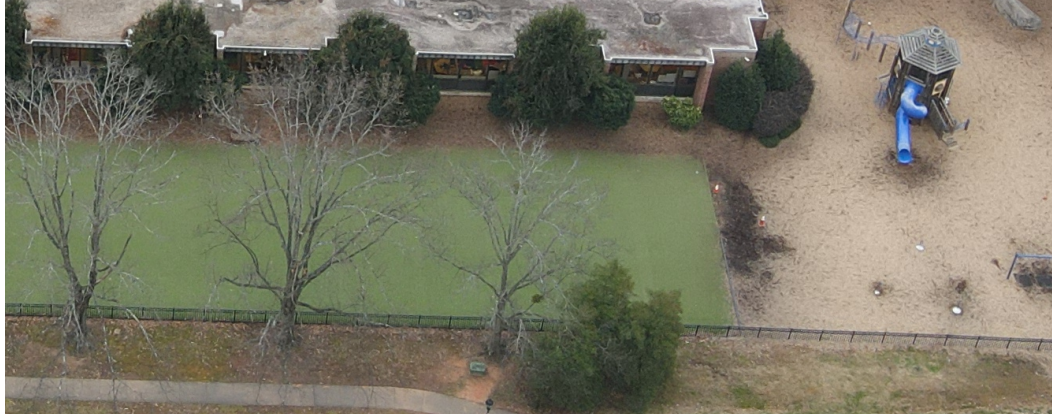
- General Layout: Water pooling at the corner of K-7 along Griffith St. Depending on the frequency and proportion of this pooling water, it may have a negative impact on associated components.
- Condition: Fair
- Comments: A lump-sum repair cost is included in the cost table.

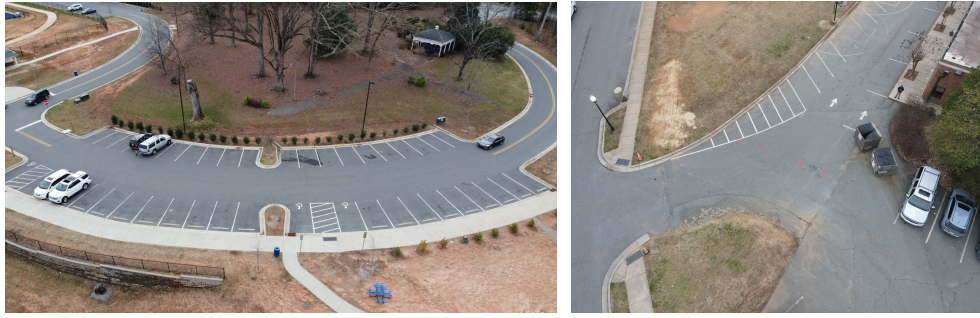
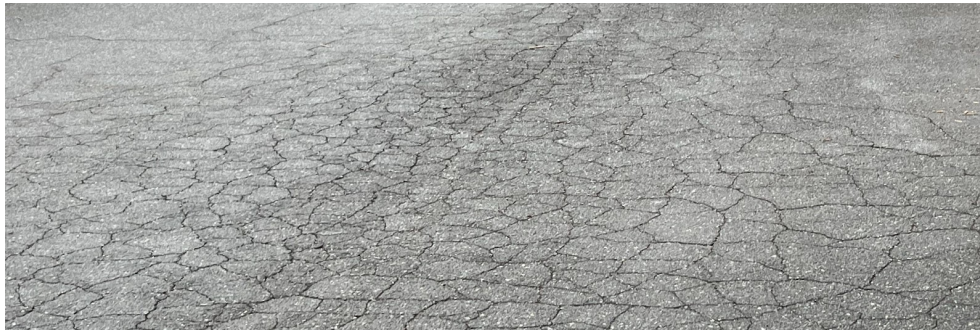
- Driveways: Present
 - Location: Throughout
 - Type: Asphalt
 - Condition: Good fair/poor
 - HS Building: Mill and overlay due in Year 1.
 - K7 Building: Mill and overlay due in Year 3.
 - Restripe and reseal for all lots.
- These costs are noted in the cost table.

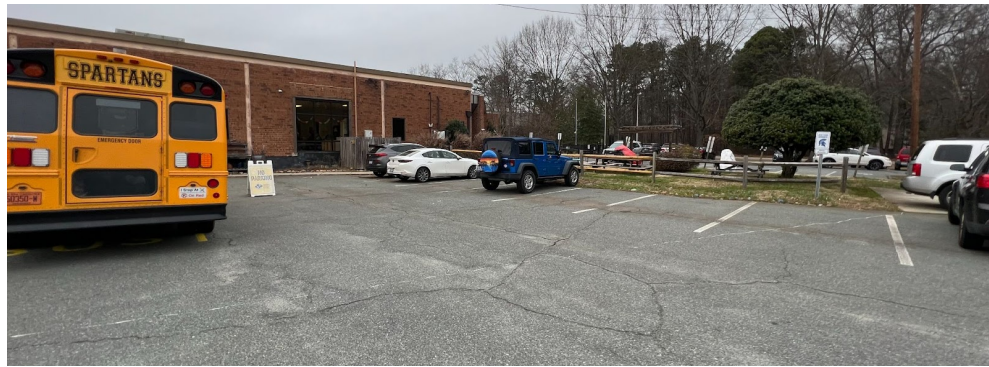
- Location: Parking lot and access driveway on the south side of the property.
 - Type: Asphalt
 - Condition: Poor
 - Comments: See above at 4.3
- A cost for this is noted in the cost table.

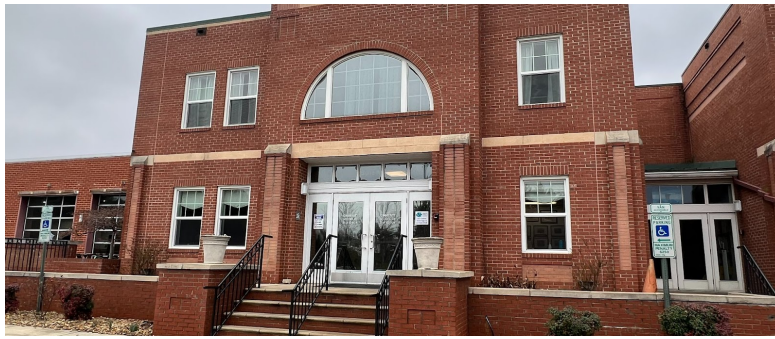
- Floor Structure: Consistent Concrete Slab-on-Grade
- Underfloor Area: N/A
- Wall Framing: Masonry, Covered Masonry
- Roof Framing: Truss
- Envelope: Brick Veneer
 - Windows: Double pane fixed windows.
 - Glazing: Serviceable
- Exterior Doors: Metal
- Windows: Fixed
- Interior Doors: Wood
- Stairways:
 - The stairway in the drama area of the high school is in a walkway, which can allow occupants' heads to collide with the stairway. This is a safety concern and should be addressed. Due to the low anticipated cost, this will not be addressed in the cost table.
- Parapets: Serviceable

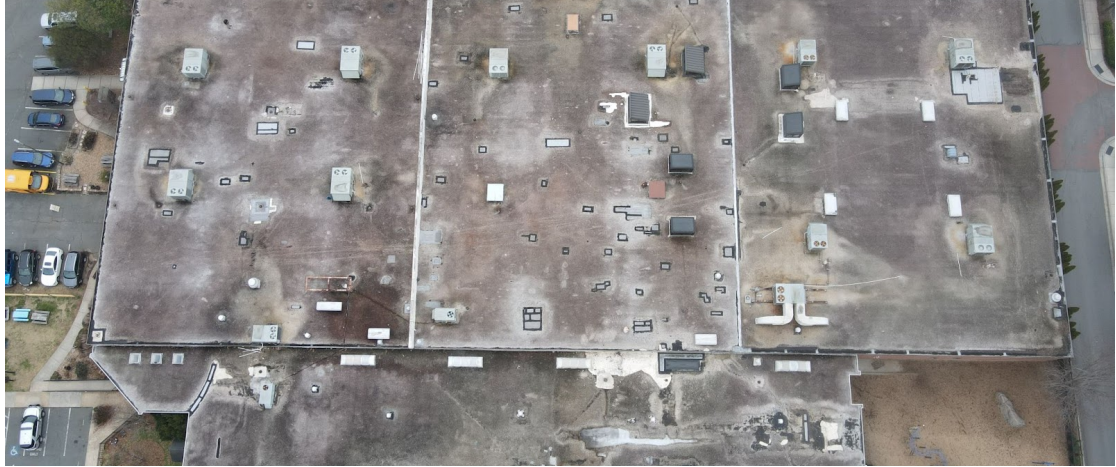
- Type: Built-up
- Slope: Flat
- Visibility: Accessed by walking and drone.
- Access: Ladder
- Condition: Poor
 - Comments: Replacement is included in the cost table
- Parapet Wall: Fair
- Roof Flashing: Poor
- Plumbing Vents: Present
- Skylights and Penetrations: Poor
- Chimney(s): Not Present
- Roof Drainage: Fair. Underground leads were not visually observed to confirm flow. Roof drain baskets were misplaced. This will be an ongoing maintenance item. The cost for this will not be listed in the cost table.
- Caulking: Present

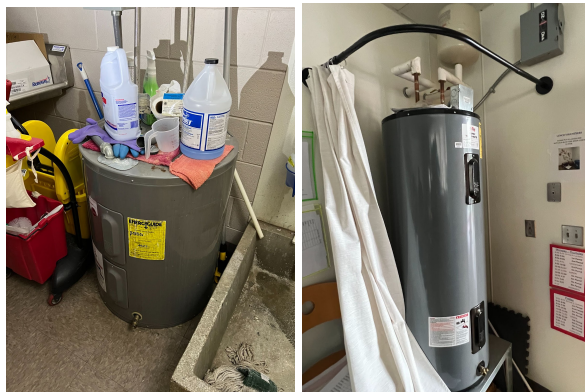
- Location(s): Non-occupied and occupied space
 - High School Water heater Mfr #: ELD52-FTB in the mini kitchen is beyond its EUL and should be considered for replacement.
 - Comments: K-7 Water heater Mfr #: PROE36 S2 RH95 in the Custodial closet is beyond its EUL and should be considered for replacement.
 - Replacement cost for this will be reflected in the cost table.

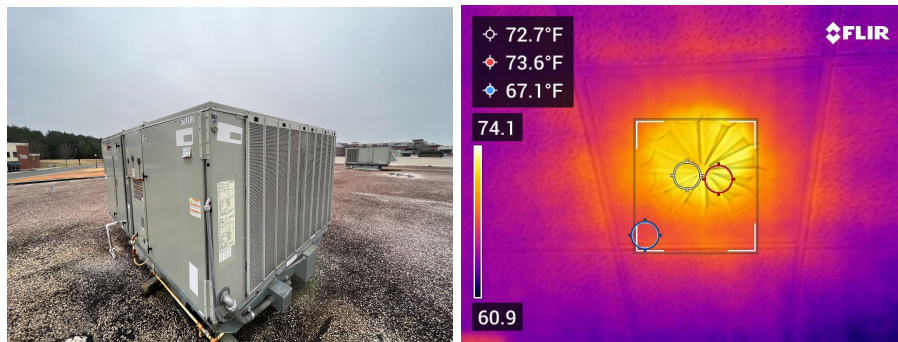
- Heating Source(s): Heat pumps, RTU, A Single Mini Split
- Type of Distribution: Forced air ductwork systems
- Routine Maintenance: Yes
- Visible Upgrades from Previous Systems: Some units were replaced and others will need to be replaced during the review period.

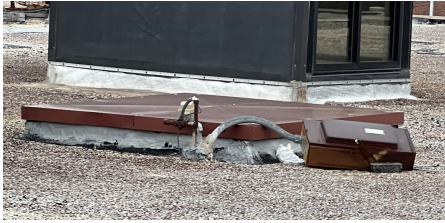
- Improperly terminated HVAC disconnect boxes laying on the roof of K-7 are considered a hazardous situation and have not been properly terminated. Due to the low cost, this will not be reflected in the cost table.
- Lighting:
 - Type(s): Various ceiling mounted
 - Location: Various
- Switches: Good
- Receptacles: Fair

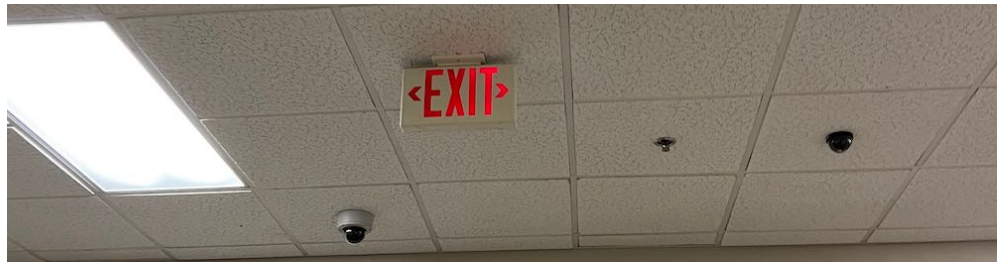
- Exit Signs: Present, some are improperly lit. Replace.
- Emergency Lighting: Present.
 - Comment: Install additional illumination around both theater areas.

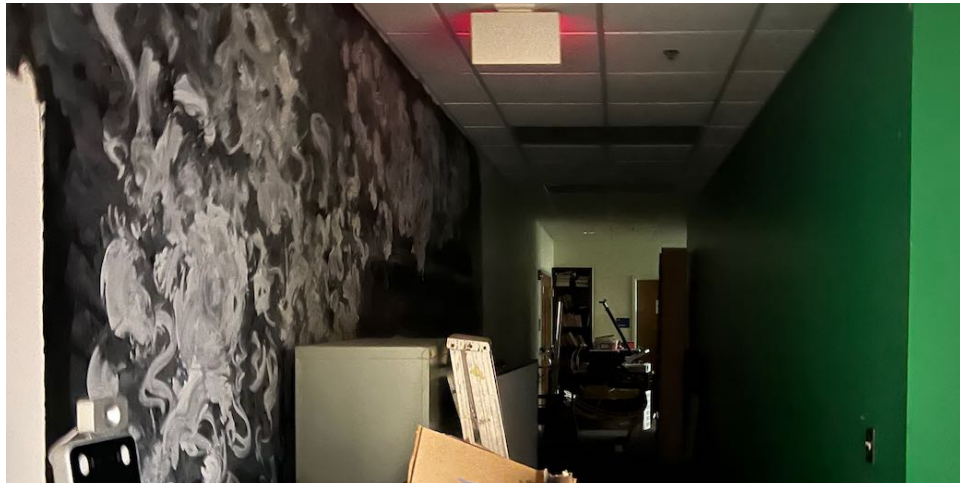
- Trip hazard / Loose railing / Improper riser/tread(s): N/A
- Improper Corridors: Lighting and travel is improper in storage areas around both theaters. Install proper lighting and remove storage from travel areas.

- Fire Separation Doors: Present, not all are listed as fire doors
 - Comment: Consult local authorities for proper horizontal exit doors.
- Do not close/latch properly at: N/A
- Wedged/blocked at: N/A
- Exit Stairwells
 - *Not Present*

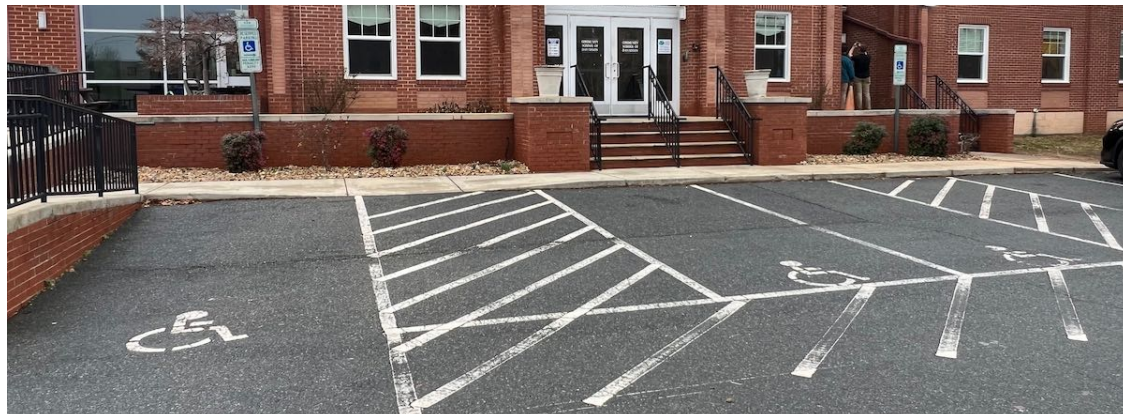
- Present: Yes
- Stamp: Blue stamp is missing at HS Building
- Striping: Present
- Van Aisle: Present
- Ramps: Present at both entrances
- Comments: Re-stripe and stamp along with regular parking lot maintenance. This is considered a maintenance cost.
