Building Sciences Consultants

Capital Needs Assessment

Community School of Davidson

Inspection Number: 20230103

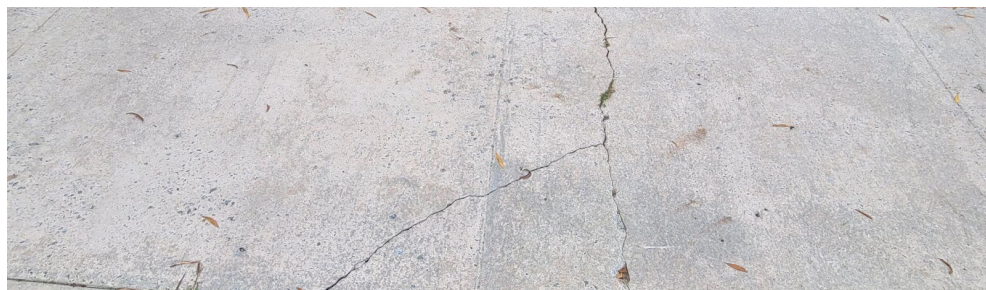
4.7. Flatwork

- Location: Throughout the parking and building areas
- Type: Concrete

- Condition: Fair

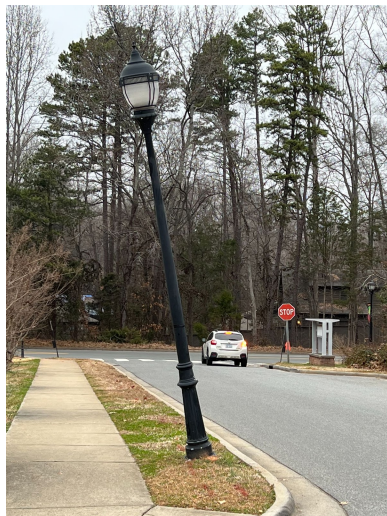
- Lighting: Pole-mounted. Sufficiency of lighting was not evaluated due to inspection conducted during daytime hours.
 - A damaged light pole was observed at K-7 on Davidson Gateway Dr. (leaning). This is a safety hazard. Repair this before failure and damage occur. The cost for this is below the threshold.

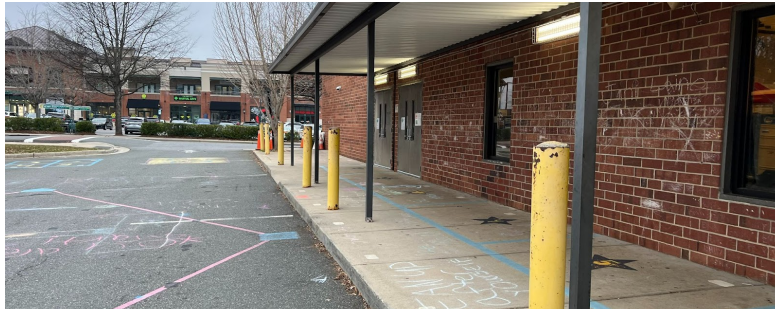
5.1. K7 Building

- Floor Structure: Consistent Concrete Slab-on-Grade
- Underfloor Area: N/A
- Wall Framing: Masonry, Covered Masonry
- Roof Framing: Truss
- Envelope: Brick Veneer
 - Windows: Double pane fixed windows.
 - Glazing: Serviceable
- Exterior Doors: Metal
- Windows: Fixed
- Interior Doors: Wood
- Parapets: Serviceable
- Vantage Point(s): All exterior from ground

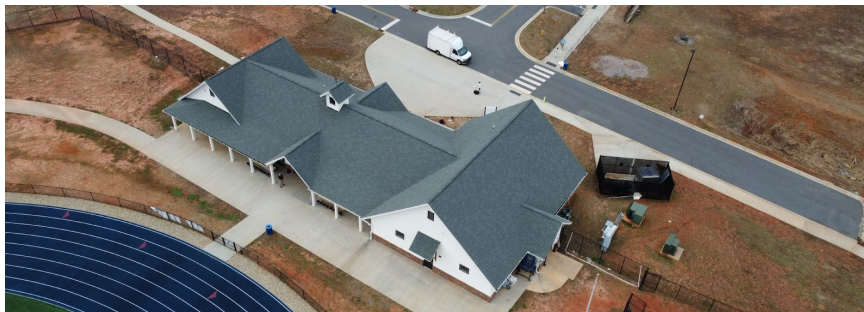
5.3. **Spartan Park Building**

- Floor Structure: Consistent Concrete Slab-on-Grade
- Underfloor Area: N/A
- Wall Framing: Wood framing
- Roof Framing: Truss
- Envelope: Fiber Cement Siding
 - Windows: Double pane fixed windows.
 - Glazing: Serviceable
- Exterior Doors: Metal
- Windows: Fixed
- Interior Doors: Wood
- Vantage Point(s): All exterior from roof, drone, ladder, and ground.

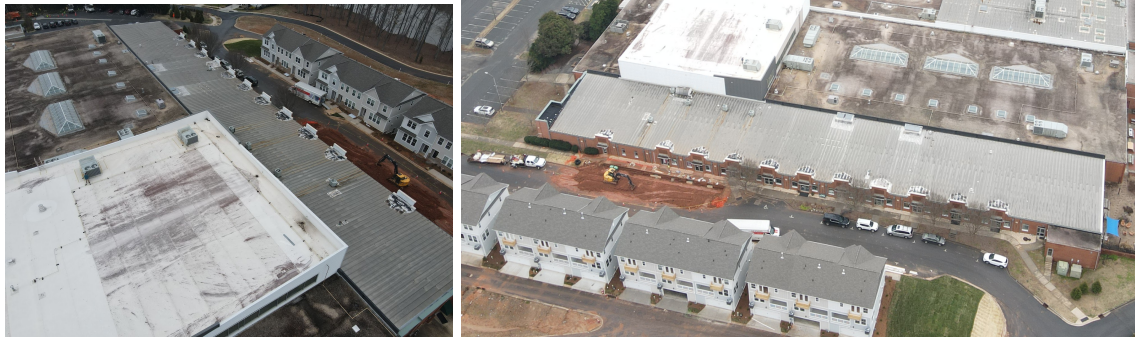
6.2. HS Building Roof

- Type: TPO, Built-up, Standing Seam, Asphalt
- Slope: Flat and Pitched
- Visibility:
 - Roofs were fully accessed and walked
- Access: Hatch
- Condition: Good
- Parapet Wall: Fair
- Roof Flashing: Fair, Poor
 - Eleven facade extensions protrude beyond the roof, at the eave along Amalfi D, creating a water intrusion issue. These facades have crickets running into the main roof. Crickets do not appear to be performing their intended function. Repairs will be needed and a cost for this is included in the cost table.
- Plumbing Vents: Present
- Chimney(s): Not Present
- Roof Drainage: Fair,
 - Underground leads were not visually observed to confirm flow. Roof drain baskets were misplaced. This will be an ongoing maintenance item. The cost for this will not be listed in the cost table.
- Caulking: Present

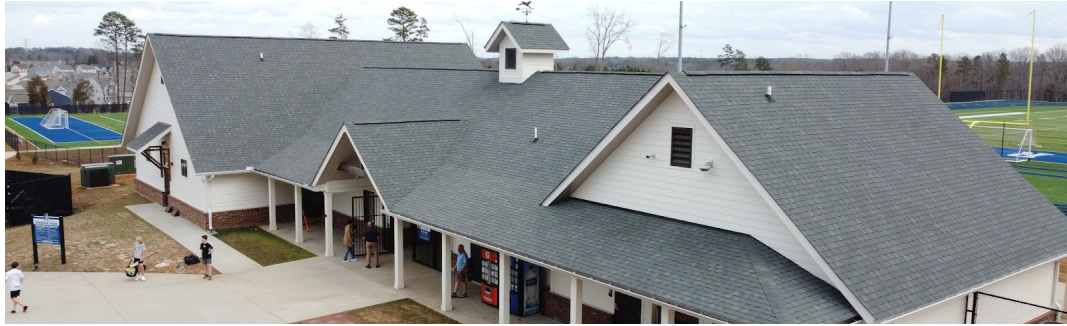
6.3. Spartan Park Roof

- Type: Asphalt
- Slope: Pitched
- Visibility:
 - Pitched roof was accessed via drone.
- Access: Hatch
- Condition: Good
- Roof Flashing: Good
- Roof Valleys: Good
- Roof Ventilation: Soffit and gable vents
- Plumbing Vents: Present
- Chimney(s): Not Present
- Roof Drainage: Good.
- Trim/Soffit/Fascia: Serviceable

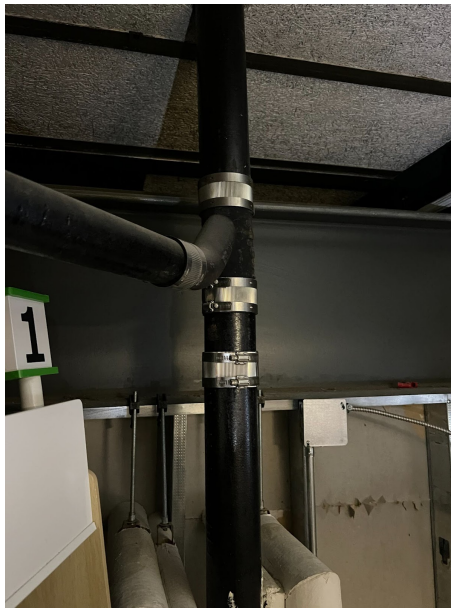
7.2. Interior Plumbing

- Fixtures: Fair
 - Drainage & Stops: Installed
 - Water Flow: Good
 - Hot/Cold: Operational
- Toilets: Present, Operable
- Pipe Supports: *Not Visible*
- Cabinets: Good.

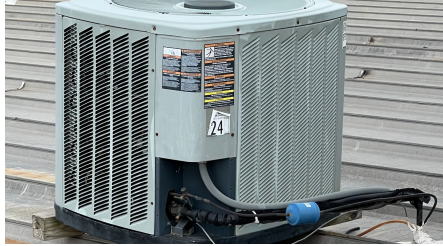
9.1. Cooling System Overview

- Cooling Type: RTU, Air Handlers with exterior AC compressors
- Type of Distribution: Forced Air, with and without ductwork
- Type of Ventilation: Passive
- Routine Maintenance Schedule for Past 24 Months: Yes
- Visible Upgrades from Previous Systems: Good

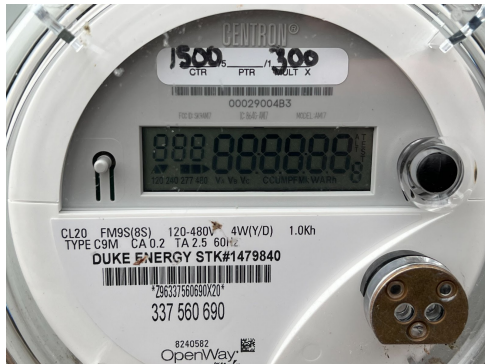
10.2. Service Entry and Meter

- Meters: Exterior, wall mounted
- Overhead Clearance: N/A
- Condition: Not Evaluated
- Evidence of moisture damage/corrosion/overheating: Not Visible

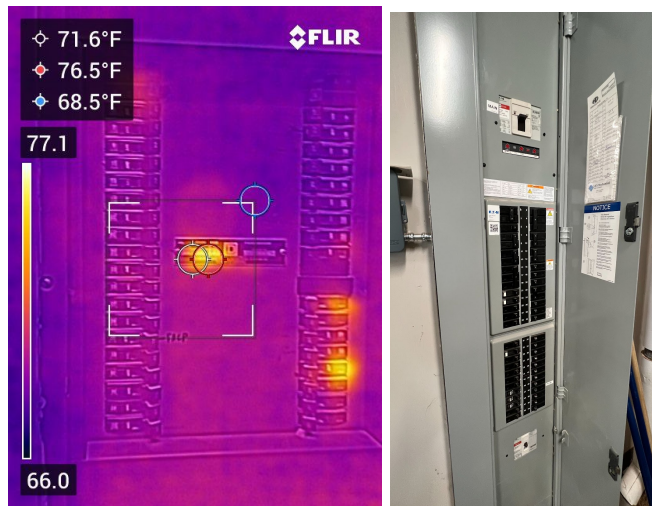
10.3. Distribution Panels

- Location(s): Various
- Condition: Good
- Corrosion / Moisture / Damage / Overheating: Not Visible
- Amperage: Varied
- Service Voltage: Listed as 110/220 Volt
- Adequate Clearance at Panel:
 - Items should not be stored in panel rooms and or stored close to the panels preventing access. Where items are blocking access to the panel they should be removed.
- Main Shutoff: Present on Main Switchboard
 - Appears grounded: Present
 - GFCI Breaker Present: GFCI/s not functional, GFCI and how it should be replaced every 10 years. Due to the low cost, this will not be included in the cost table
 - AFCI Breaker Present: Not Visible
- Main Wire: Not Evaluated
- Breakers Properly Labeled: Yes
- Branch Wiring: Not Visible
 - Condition: Not Visible

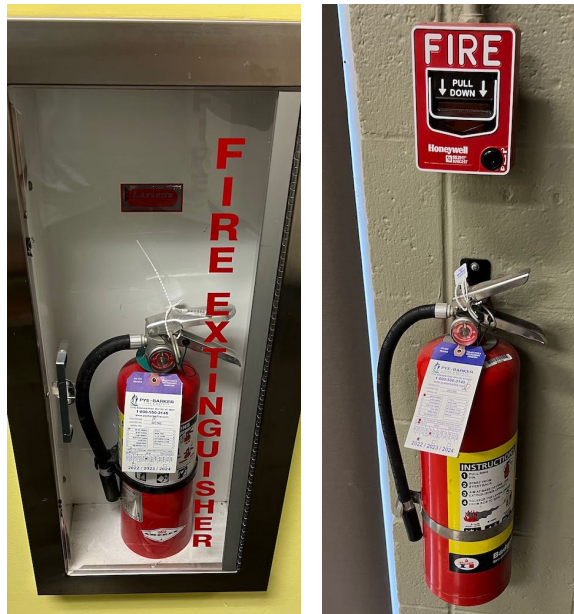
12.6. Fire Extinguishers

- Stored within 30' of commercial cooking area using oil or fat: N/A
- Access: Not Visible
- Comments: Service and re-certify fire extinguishers yearly

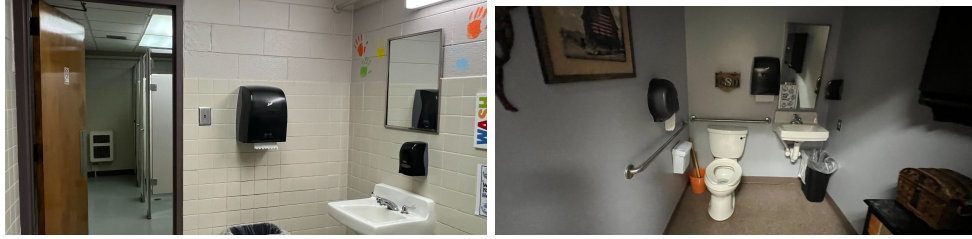
13.3. Bathrooms

- Flooring: Ceramic Tile, Linoleum/Vinyl
- Ceilings: Painted drywall
- Walls: Block, Tile, Painted drywall
- Window(s): N/A
- Lighting: Various
- Electrical Receptacles: Present. Ensure all bathroom outlets are GFCI and operational.
- Fixtures: Toilets, sinks
